Manhole Inspection Summary

Manhole # S27M1_013MH

Location Address: **2724 Fisk Rd.**

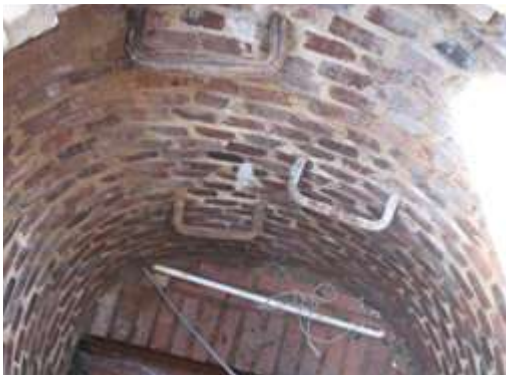
Steps Count: **3** Missing: **0** ☒ **Corroded**

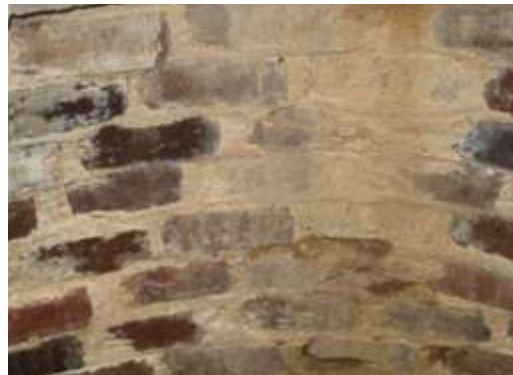
Defect 2

Infiltration

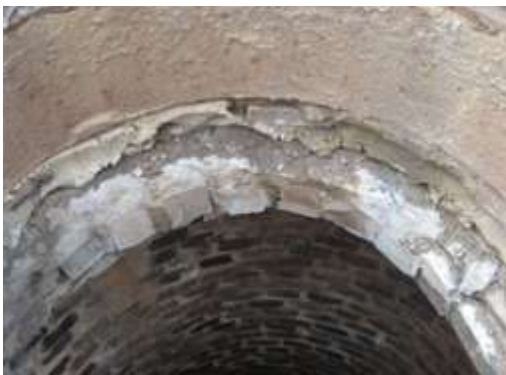
Defect 1

Frame Offset: **2** (in.) Condition: ☒ Sound ☐ Cracked ☐ Leaks

Frame Offset
